National Transportation Safety Board Marine Accident Brief

Fire and Explosions On Board Towing Vessel *Safety Runner* and Kirby Barges *28182* and *28194*

Accident no. DCA13NM019

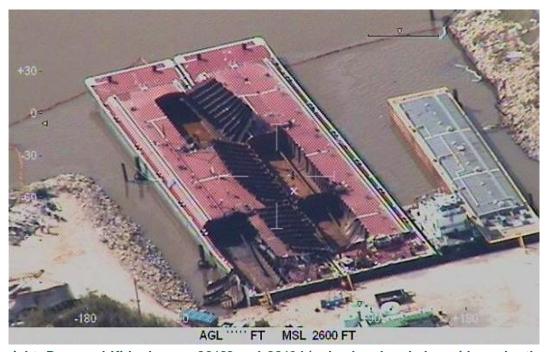
Left to right: Damaged Kirby barges 28182 and 28194 (red-colored and alongside each other), and towing vessel Safety Runner (white-colored). To the right of the Safety Runner is another barge, DM 975 (gray-colored), which was not damaged in the fire. (Photo by the United States Coast Guard)

Investigators could not determine the source of ignition inside the *Safety Runner*'s engine room. This space, together with the vessel's main deck area, was extensively fire-damaged. Kirby declared its two barges total losses. The damage amount for the towing vessel and two barges was estimated to be \$5.7 million. The *Ricky J Leboeuf* and *DM 976* were not damaged.

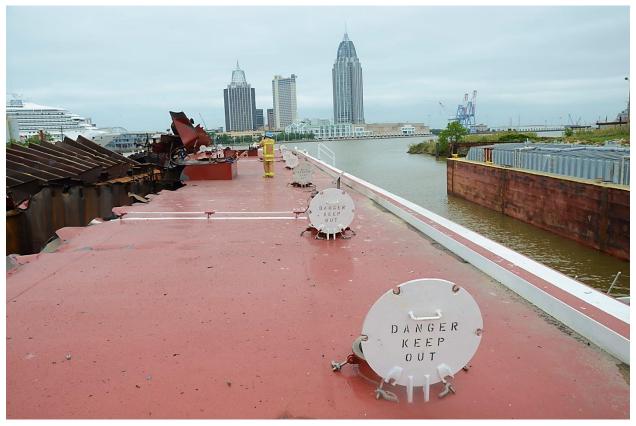
Between 1200 and 1300, the two ORC employees opened all cargo tanks and hatches on the Kirby barges and began to strip the tanks of residual gasoline. Flammable vapors vented to the atmosphere from the hatches and deck openings. Several hours later, at 2000, the two ORC employees finished stripping the tanks and installed six portable pneumatic fans on board each barge to help ventilate the tanks. About the time that the portable fans began ventilating the tanks, recorded weather data reported an air temperature of about 70°F, humidity of 96 percent, and calm winds.

Open tank hatches on *Kirby 28194*, photographed after the accident, through which flammable vapors were being vented. Undamaged barge *DM 976* can be seen on the right. (Photo by the Coast Guard)

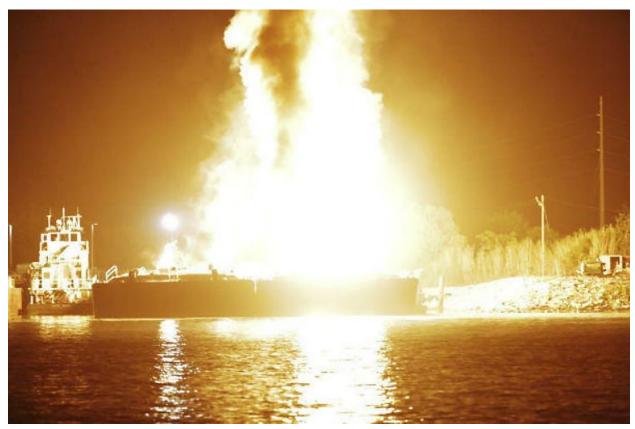
Shortly thereafter, witnesses reported seeing flames shooting along both sides of the *Safety Runner* and onto the two Kirby barges, resulting in several explosions. The crews of the *Safety Runner* and the *Ricky J Leboeuf* sounded their vessels' general alarms. The *Safety Runner*'s entire crew then abandoned the vessel ashore and the *Ricky J Leboeuf*'s crewmembers disconnected their vessel from the Kirby barges and maneuvered away from the facility.

The accident scene. (Photo by the Coast Guard)
